## Appendix V – Marsh Habitat Summary Data

## Appendix VII – Marsh Compensation Site Descriptions

Figure 1. Locations of FREMP compensation marshes surveyed July-October 2015. Large scale map features (e.g. precise locations, site boundaries, vegetation communities) can be viewed on the FREMP-BIEAP Atlas online, under the 2015 Field Data map layer: [http://www.cmNBC.ca/atlas\\_gallery/fremp-bieap-habitat-atlas](http://www.cmNBC.ca/atlas_gallery/fremp-bieap-habitat-atlas).

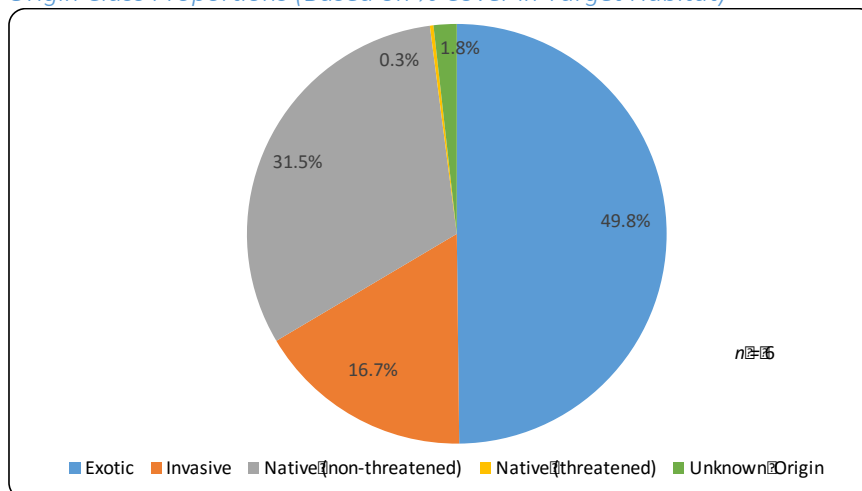
### Origin Class Proportions (Based on % Cover in Target Habitat)

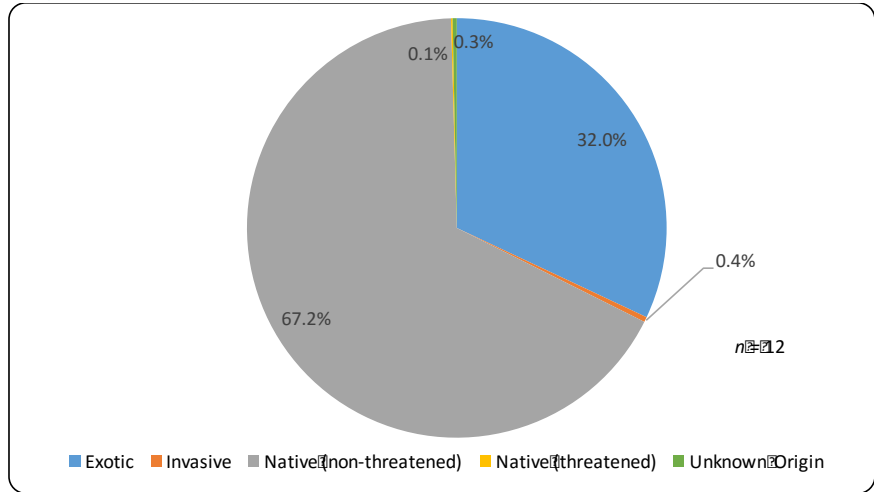
Origin Class Proportions (Based on % Cover in Target Habitat)

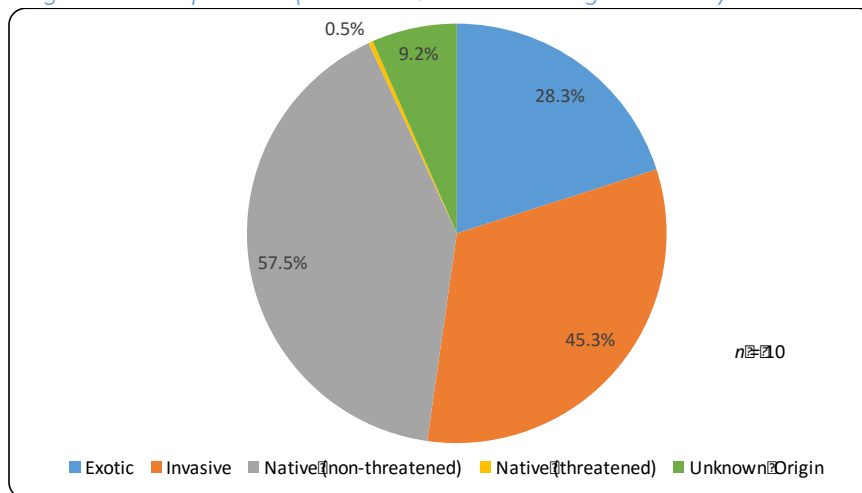
### Origin Class Proportions (Based on % Cover in Target Habitat)

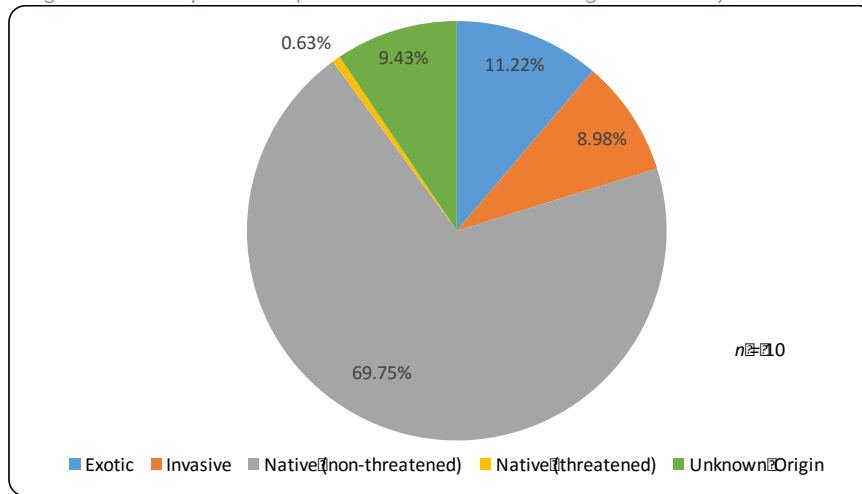
### Origin Class Proportions (Based on % Cover in Target Habitat)

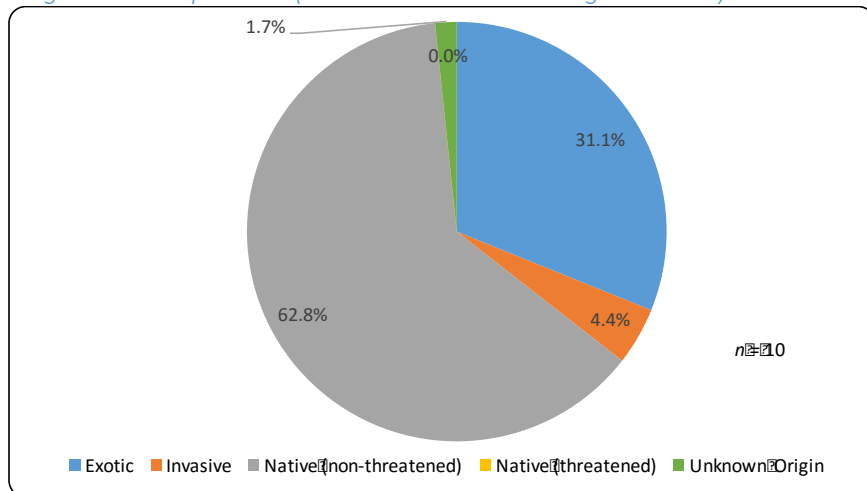
### Origin Class Proportions (Based on % Cover in Target Habitat)

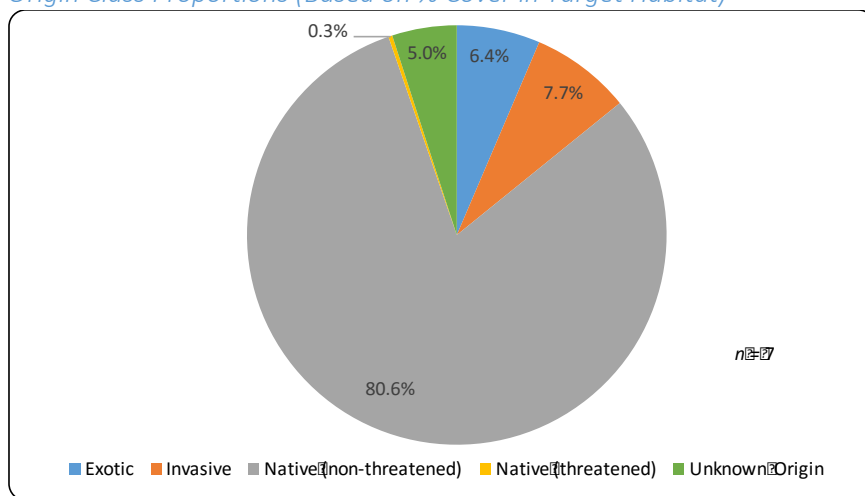
### Origin Class Proportions (Based on % Cover in Target Habitat)

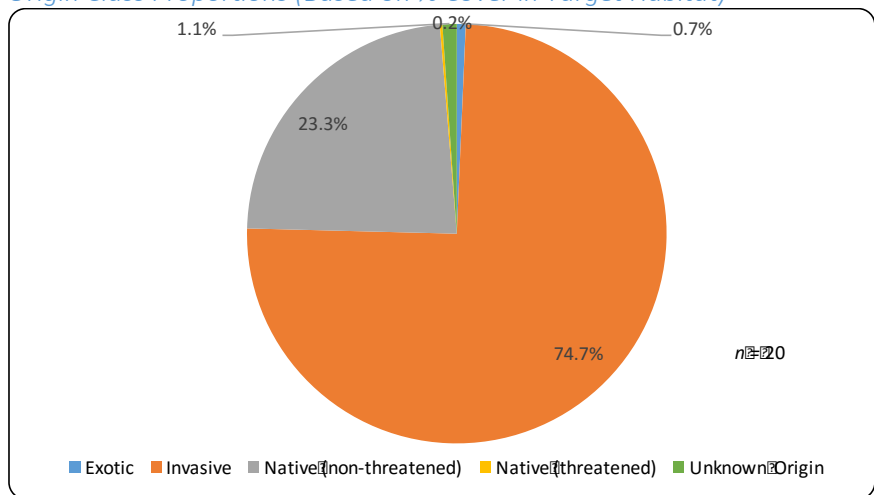
Origin Class Proportions (Based on % Cover in Target Habitat)

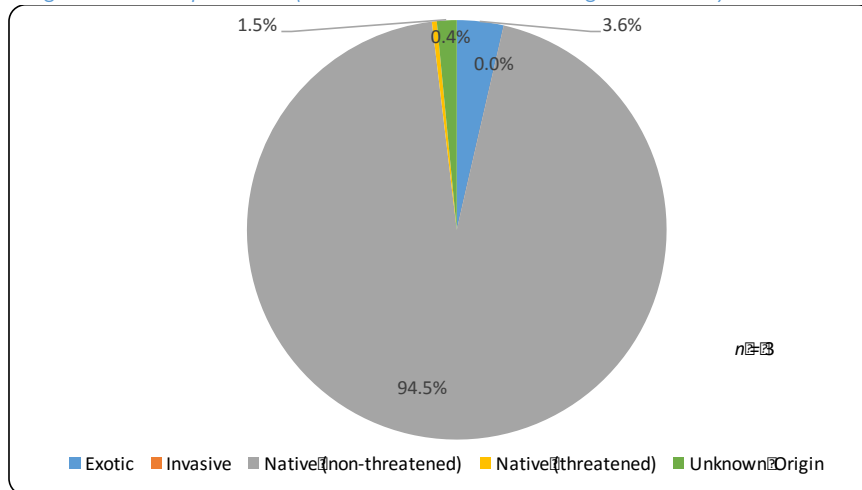
### Origin Class Proportions (Based on % Cover in Target Habitat)

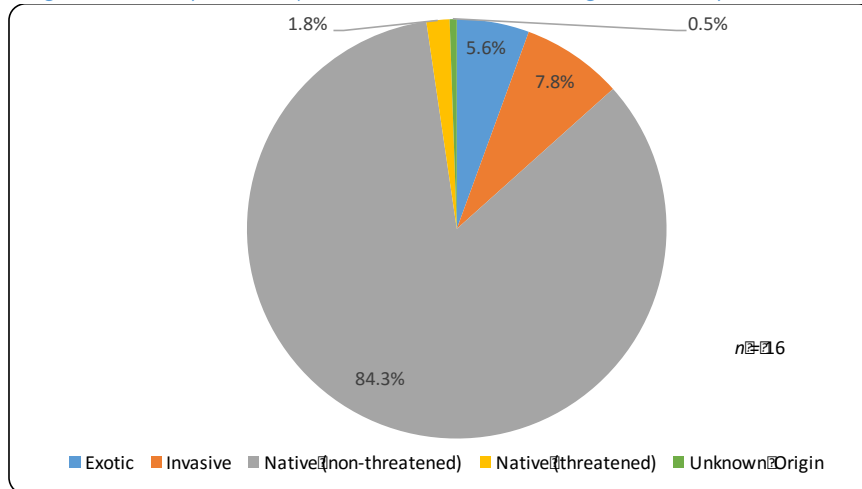
### Origin Class Proportions (Based on % Cover in Target Habitat)

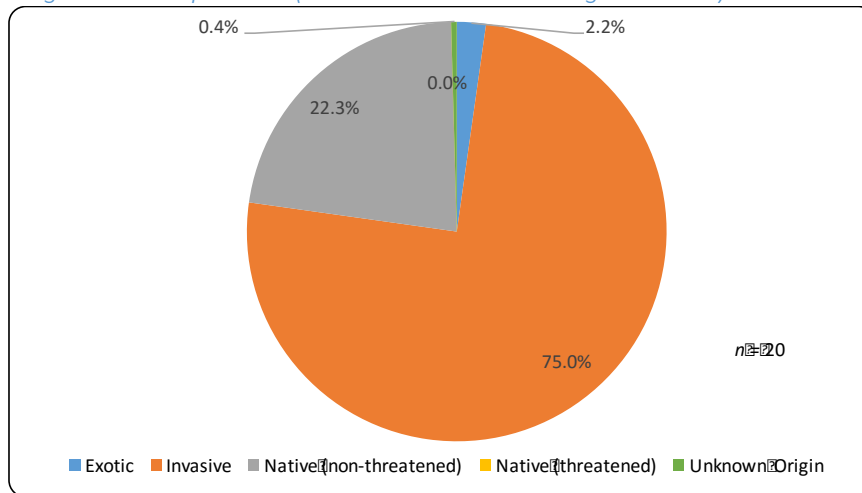
### Origin Class Proportions (Based on % Cover in Target Habitat)

Community	Common Name	Scientific Name	Origin (N/T/E/I)	Wetland Indicator Status	Mean Absolute % Cover	CI (95%)	n	Relative Dominance (%)
1	lesser cattail	<i>Typha angustifolia</i>	I	1	51.3	13.5	20	92.7

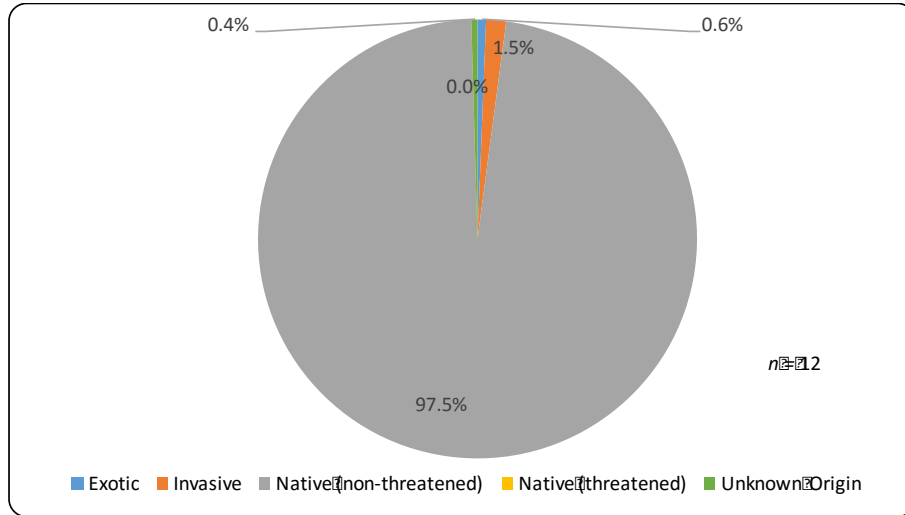
### Origin Class Proportions (Based on % Cover in Target Habitat)

Community	Common Name	Scientific Name	Origin (N/T/E/I)	Wetland Indicator Status	Mean Absolute % Cover	CI (95%)	n	Relative Dominance (%)
1	Baltic rush	<i>Juncus balticus</i>	N	2	57.5	13.7	12	63.2
1	Lyngbye's sedge	<i>Carex lyngbyei</i>	N	1	31.3	10.6	12	34.4

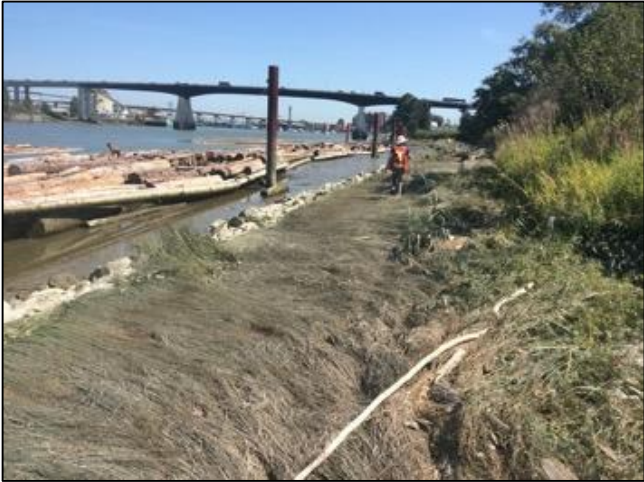
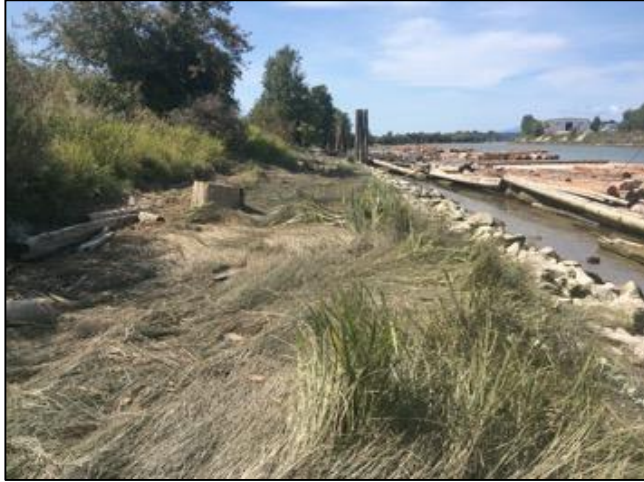
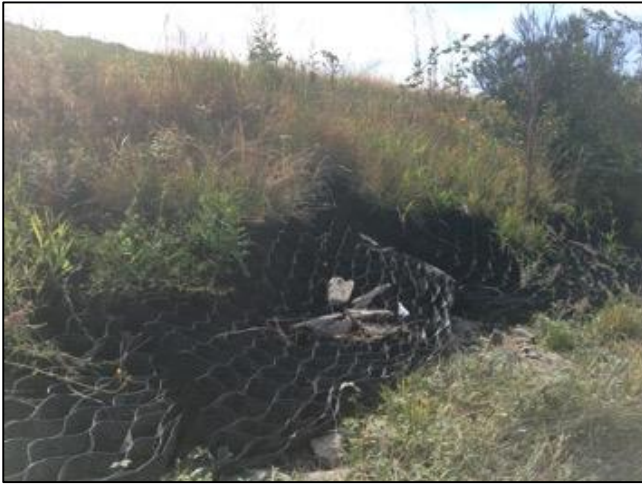
Base of backshore riprap slope is severely eroded (see photo). Invasive species are present, but are not displacing native species (1.5% of total vegetative cover). Some wood debris (large and small) was observed. Some evidence of waterfowl grazing.

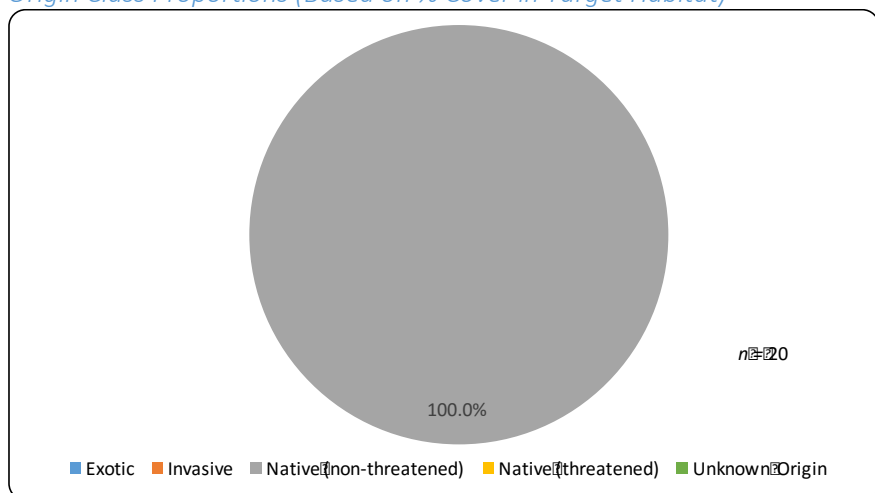
### Origin Class Proportions (Based on % Cover in Target Habitat)

Community	Common Name	Scientific Name	Origin (N/T/E/I)	Wetland Indicator Status	Mean Absolute % Cover	CI (95%)	n	Relative Dominance (%)
1	Lyngbye's sedge	<i>Carex lyngbyei</i>	N	1	65.9	17.9	20	83.4
1	Baltic rush	<i>Juncus balticus</i>	N	2	22.4	15.5	20	16.4

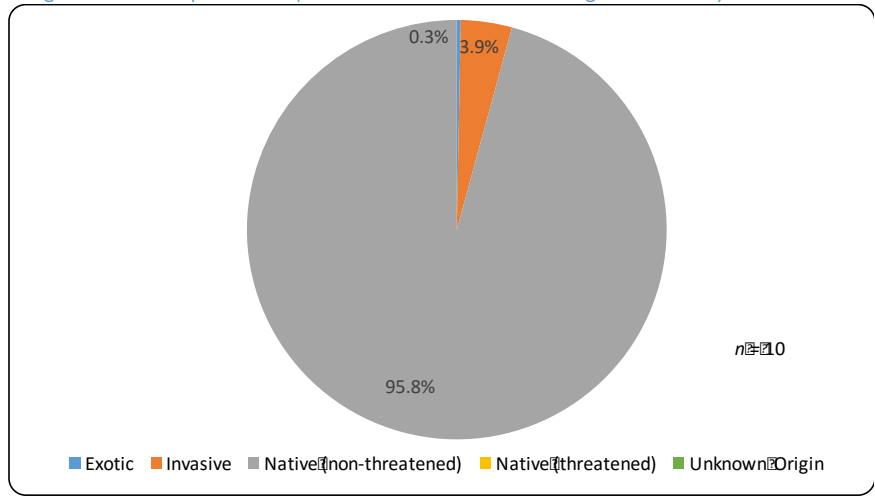
Origin Class Proportions (Based on % Cover in Target Habitat)

Community	Common Name	Scientific Name	Origin (N/T/E/I)	Wetland Indicator Status	Mean Absolute % Cover	CI (95%)	n	Relative Dominance (%)
1	Lyngbye's sedge	<i>Carex lyngbyei</i>	N	1	91.6	3.8	10	97.9

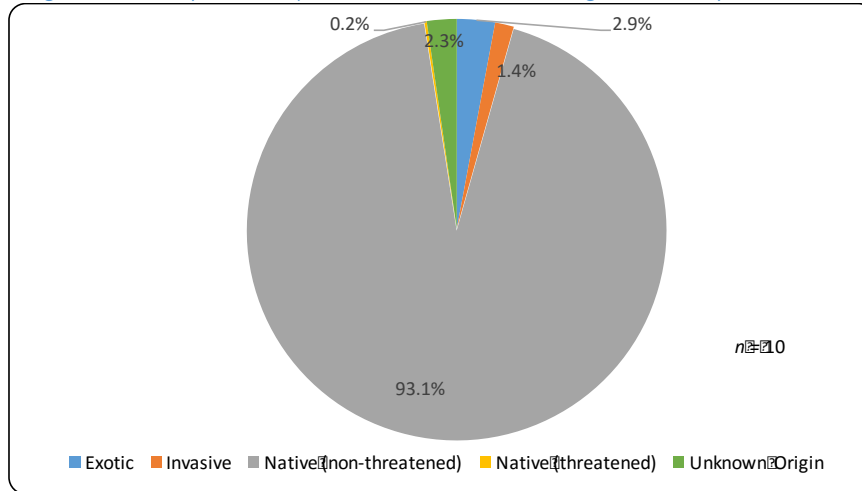
### Origin Class Proportions (Based on % Cover in Target Habitat)

Community	Common Name	Scientific Name	Origin (N/T/E/I)	Wetland Indicator Status	Mean Absolute % Cover	CI (95%)	n	Relative Dominance (%)
1	Baltic rush	<i>Juncus balticus</i>	N	2	58.8	20.9	10	56.5
1	Lyngbye's sedge	<i>Carex lyngbyei</i>	N	1	32.6	20.3	10	34.8

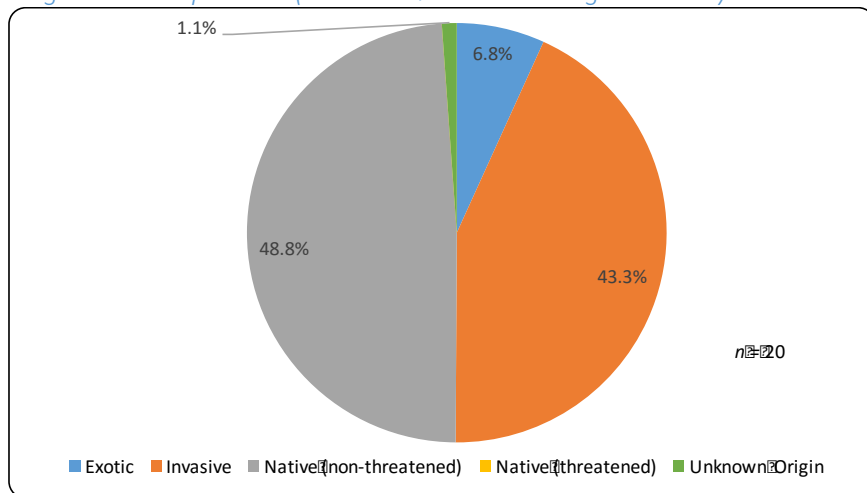
*Origin Class Proportions (Based on % Cover in Target Habitat)*

Community	Common Name	Scientific Name	Origin (N/T/E/I)	Wetland Indicator Status	Mean Absolute % Cover	CI (95%)	n	Relative Dominance (%)
1	reed canarygrass	<i>Phalaris arundinacea</i>	I	2	26.4	12.6	20	41.4
1	Baltic rush	<i>Juncus balticus</i>	N	2	13.7	11.9	20	14.3
1	purple loosestrife	<i>Lythrum salicaria</i>	I	2	9.4	4.7	20	12.8

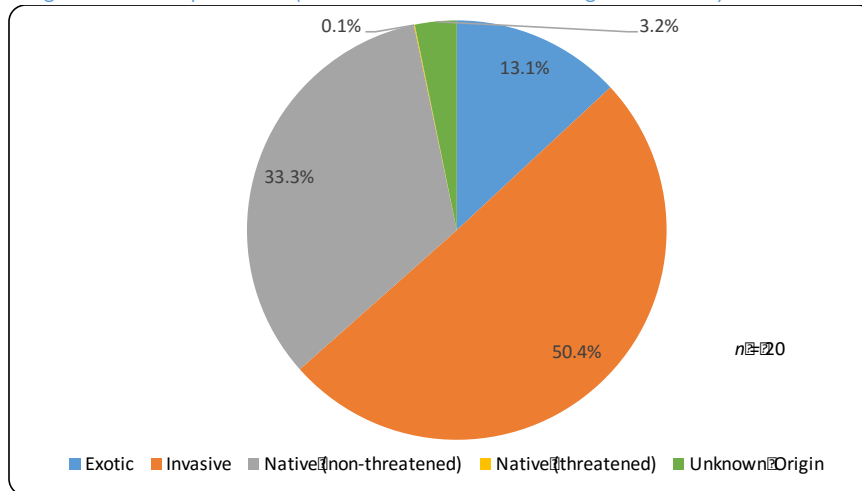
### Origin Class Proportions (Based on % Cover in Target Habitat)

Community	Common Name	Scientific Name	Origin (N/T/E/I)	Wetland Indicator Status	Mean Absolute % Cover	CI (95%)	n	Relative Dominance (%)
1	reed canarygrass	<i>Phalaris arundinacea</i>	I	2	45.6	14.7	20	54.0

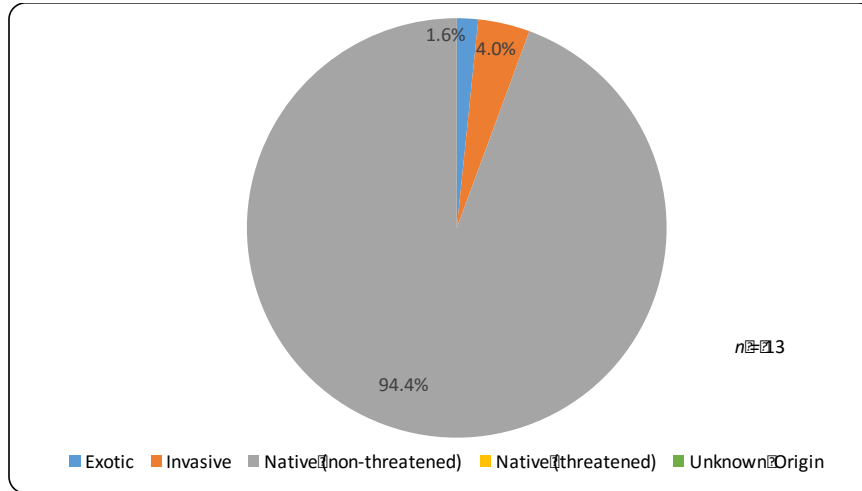
### Origin Class Proportions (Based on % Cover in Target Habitat)

Community	Common Name	Scientific Name	Origin (N/T/E/I)	Wetland Indicator Status	Mean Absolute % Cover	CI (95%)	n	Relative Dominance (%)
1	Baltic rush	<i>Juncus balticus</i>	N	2	66.2	13.1	13	86.7

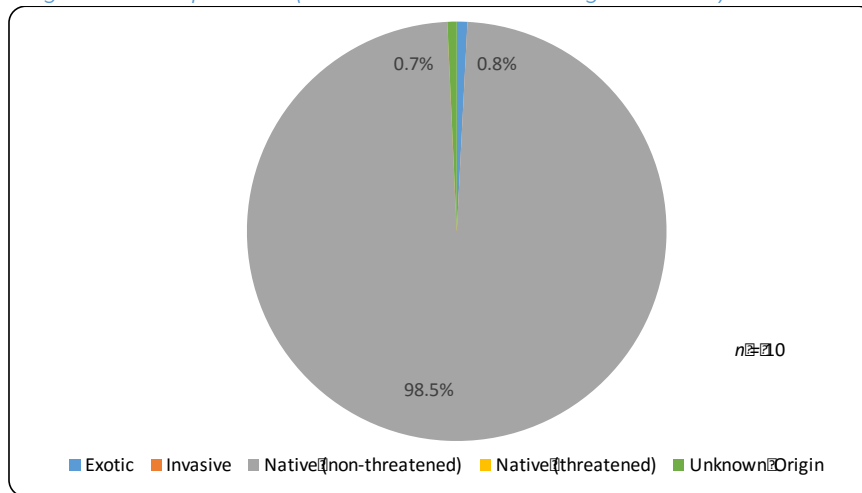
### Origin Class Proportions (Based on % Cover in Target Habitat)

Community	Common Name	Scientific Name	Origin (N/T/E/I)	Wetland Indicator Status	Mean Absolute % Cover	CI (95%)	n	Relative Dominance (%)
1	Lyngbye's sedge	<i>Carex lyngbyei</i>	N	1	54.0	27.1	10	72.7
1	Baltic rush	<i>Juncus balticus</i>	N	2	39.0	27.3	10	26.3

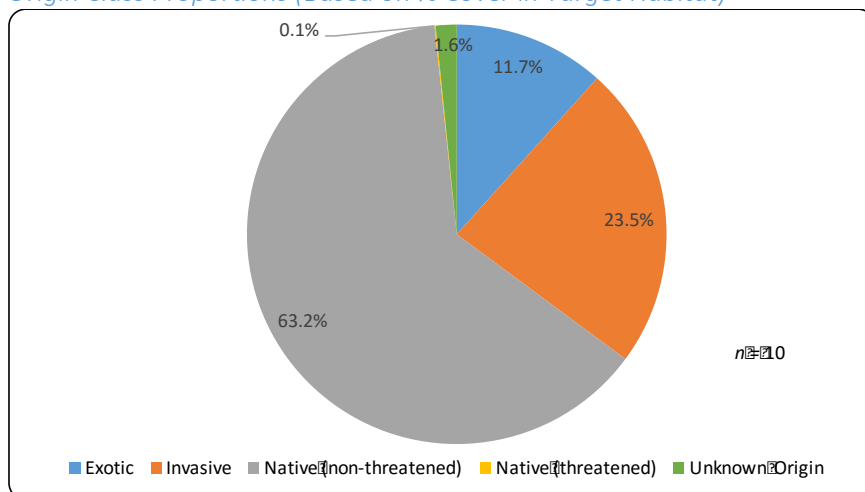
### Origin Class Proportions (Based on % Cover in Target Habitat)

Community	Common Name	Scientific Name	Origin (N/T/E/I)	Wetland Indicator Status	Mean Absolute % Cover	CI (95%)	n	Relative Dominance (%)
1	Lyngbye's sedge	<i>Carex lyngbyei</i>	N	1	48.2	23.4	10	52.1
1	reed canarygrass	<i>Phalaris arundinacea</i>	I	2	17.3	18.8	10	16.4
1	creeping bentgrass	<i>Agrostis stolonifera</i>	E	3	12.7	7.6	10	13.7

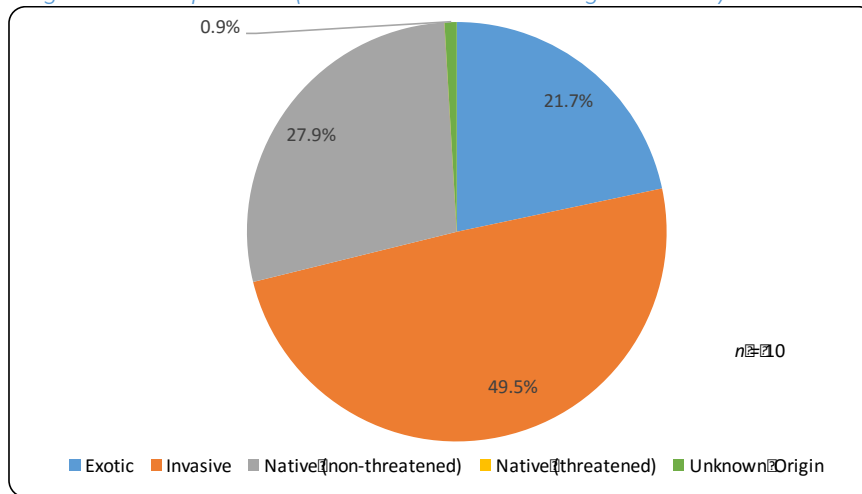
### Origin Class Proportions (Based on % Cover in Target Habitat)

Community	Common Name	Scientific Name	Origin (N/T/E/I)	Wetland Indicator Status	Mean Absolute % Cover	CI (95%)	n	Relative Dominance (%)
1	reed canarygrass	<i>Phalaris arundinacea</i>	I	2	26.7	17.4	10	26.1
1	creeping bentgrass	<i>Agrostis stolonifera</i>	E	3	22.0	17.3	10	26.0
1	purple loosestrife	<i>Lythrum salicaria</i>	I	1	18.2	15.1	10	19.8
1	Lyngbye's sedge	<i>Carex lyngbyei</i>	N	1	14.4	13.6	10	16.1

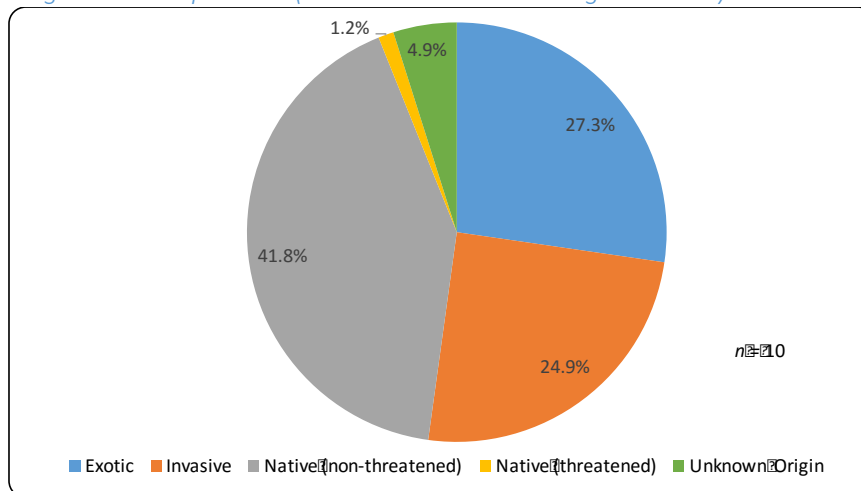
### Origin Class Proportions (Based on % Cover in Target Habitat)

Community	Common Name	Scientific Name	Origin (N/T/E/I)	Wetland Indicator Status	Mean Absolute % Cover	CI (95%)	n	Relative Dominance (%)
1	creeping bentgrass	<i>Agrostis stolonifera</i>	E	3	23.7	17.9	10	31.6
1	reed canarygrass	<i>Phalaris arundinacea</i>	I	2	18.6	17.2	10	24.8
1	common spike-rush	<i>Eleocharis palustris</i>	N	1	12.4	10.2	10	12.4

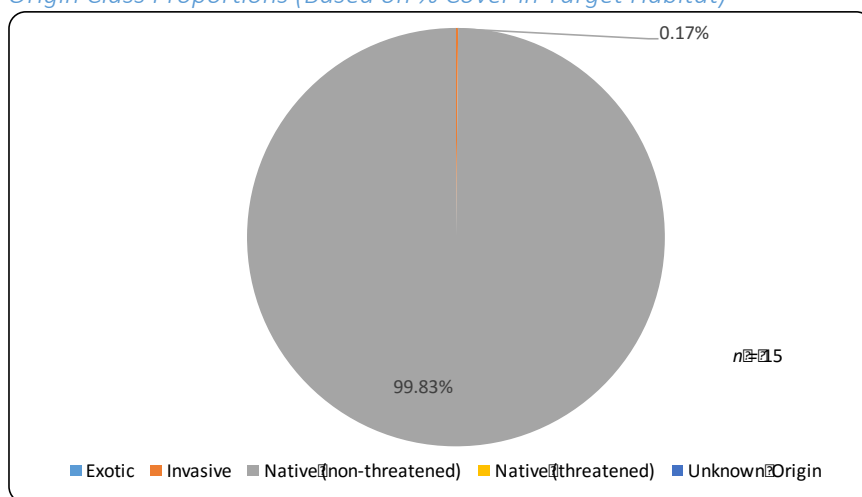
### Origin Class Proportions (Based on % Cover in Target Habitat)

Community	Common Name	Scientific Name	Origin (N/T/E/I)	Wetland Indicator Status	Mean Absolute % Cover	CI (95%)	n	Relative Dominance (%)
1	Baltic rush	<i>Juncus balticus</i>	N	2	64.8	11.7	15	86.8
1	Lyngbye's sedge	<i>Carex lyngbyei</i>	N	1	13.4	7.7	15	13.2

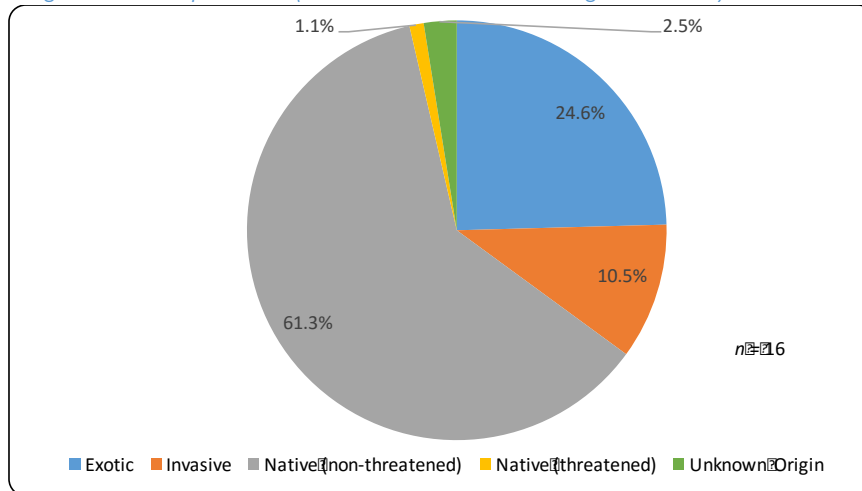
### Origin Class Proportions (Based on % Cover in Target Habitat)

Community	Common Name	Scientific Name	Origin (N/T/E/I)	Wetland Indicator Status	Mean Absolute % Cover	CI (95%)	n	Relative Dominance (%)
1	Lyngbye's sedge	<i>Carex lyngbyei</i>	N	1	45.9	15.7	16	49.1
1	creeping bentgrass	<i>Agrostis stolonifera</i>	E	3	29.4	7.8	16	31.4

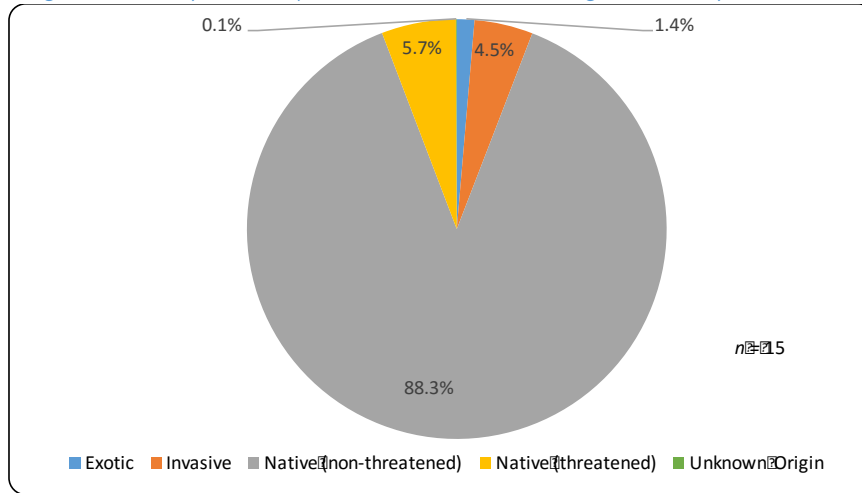
### Origin Class Proportions (Based on % Cover in Target Habitat)

Community	Common Name	Scientific Name	Origin (N/T/E/I)	Wetland Indicator Status	Mean Absolute % Cover	CI (95%)	n	Relative Dominance (%)
1	Lyngbye's sedge	<i>Carex lyngbyei</i>	N	1	63.4	15.1	15	81.6

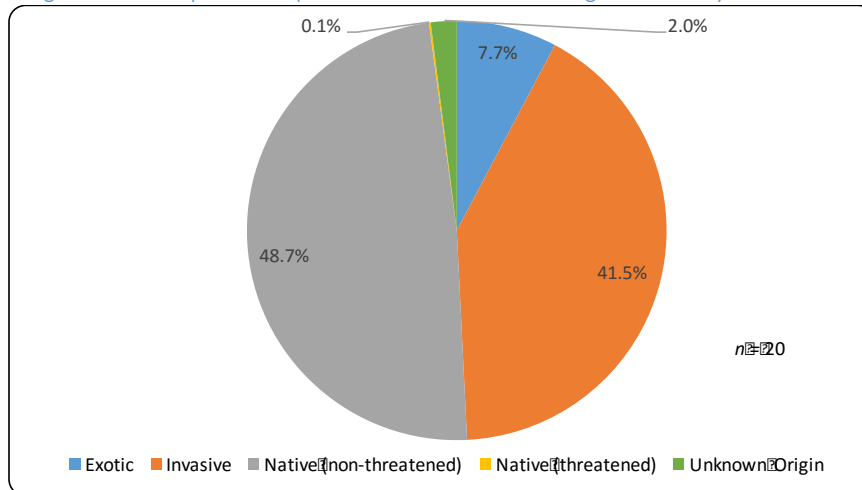
### Origin Class Proportions (Based on % Cover in Target Habitat)

Community	Common Name	Scientific Name	Origin (N/T/E/I)	Wetland Indicator Status	Mean Absolute % Cover	CI (95%)	n	Relative Dominance (%)
1	common cattail	<i>Typha latifolia</i>	N	1	9.1	8.0	20	25.3
1	blue cattail	<i>Typha x glauca</i>	I	1	16.1	13.3	20	22.4
1	swamp horsetail	<i>Equisetum fluviatile</i>	N	1	9.0	10.0	20	15.0

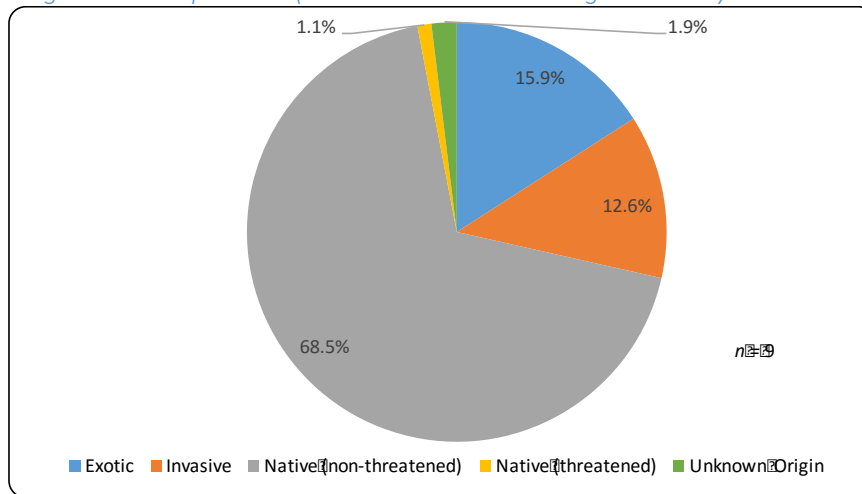
### Origin Class Proportions (Based on % Cover in Target Habitat)

Community	Common Name	Scientific Name	Origin (N/T/E/I)	Wetland Indicator Status	Mean Absolute % Cover	CI (95%)	n	Relative Dominance (%)
1	Lyngbye's sedge	<i>Carex lyngbyei</i>	N	1	44.9	23.9	9	55.6
2	nodding beggarticks	<i>Bidens cernua</i>	N	2	4.0	3.6	9	30.2
2	broad-leaved arrowhead	<i>Sagittaria latifolia</i>	N	1	3.4	2.9	9	26.0
2	common cattail	<i>Typha latifolia</i>	N	1	6.1	9.8	9	23.1

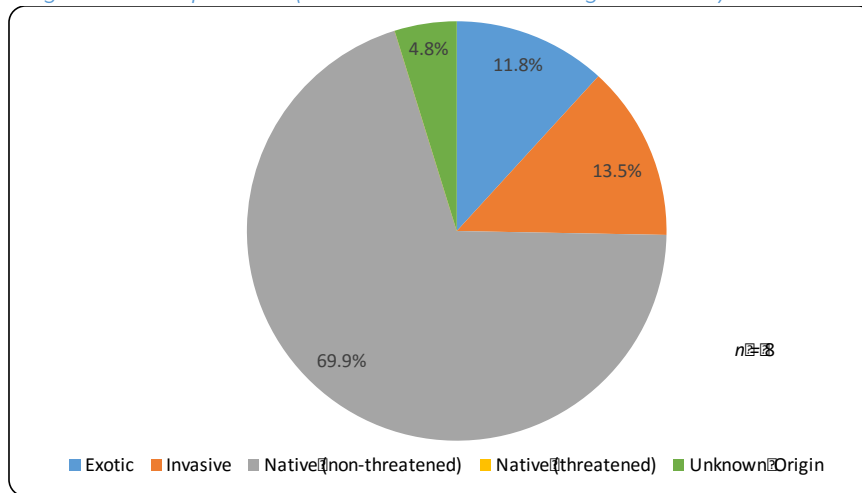
### Origin Class Proportions (Based on % Cover in Target Habitat)

Community	Common Name	Scientific Name	Origin (N/T/E/I)	Wetland Indicator Status	Mean Absolute % Cover	CI (95%)	n	Relative Dominance (%)
1	swamp horsetail	<i>Equisetum fluviatile</i>	N	1	2.4	2.3	8	21.2
1	Baltic rush	<i>Juncus balticus</i>	N	2	8.8	17.1	8	12.7
1	common cattail	<i>Typha latifolia</i>	N	1	2.8	3.6	8	12.0
2	Lyngbye's sedge	<i>Carex lyngbyei</i>	N	1	3.3	6.5	3	36.4
2	reed canarygrass	<i>Phalaris arundinacea</i>	I	2	3.3	6.5	3	36.4
2	purple loosestrife	<i>Lythrum salicaria</i>	I	1	2.0	3.9	3	21.8

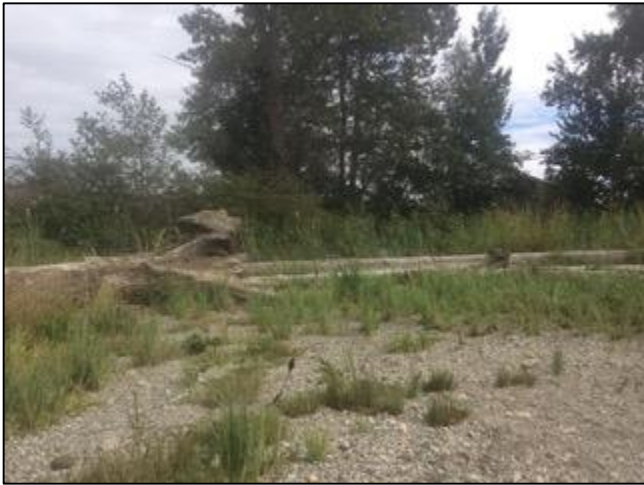
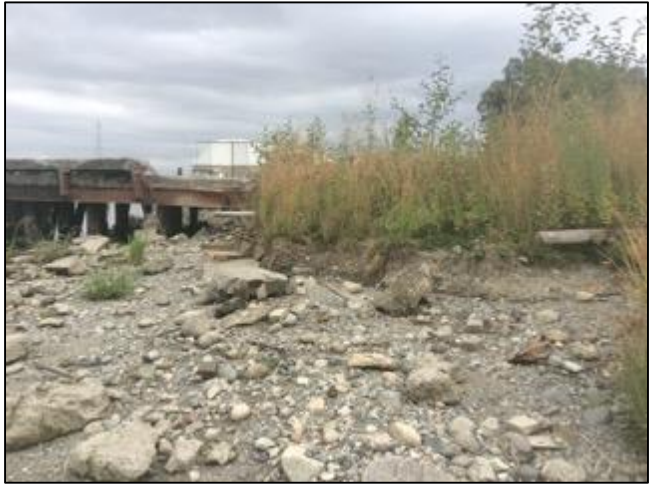
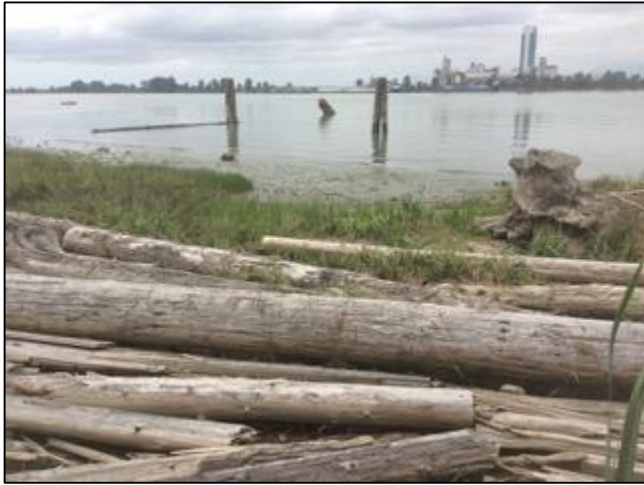
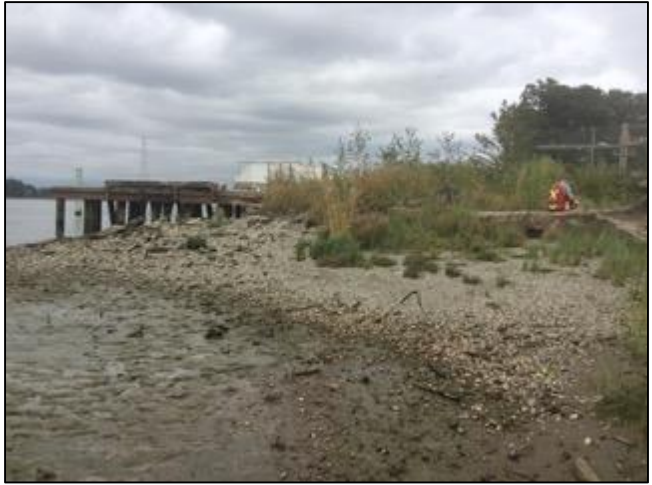
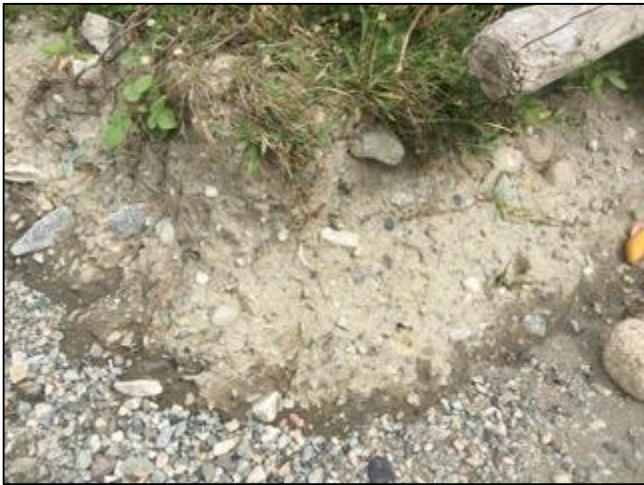
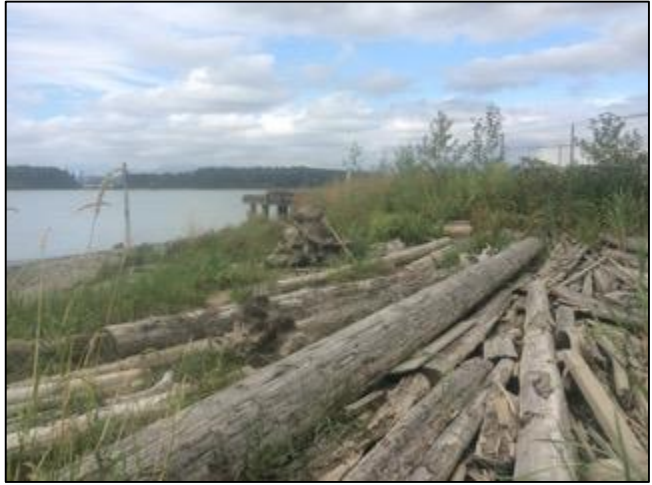
Erosion appears to be undercutting marsh foreshore (see photos), limiting vegetative colonization, and scouring all fine particles from substrate. No waterfowl were observed nearby, but *Carex lyngbyei* appears to be grazed. Log debris is reducing site productivity through grounding and smothering marsh vegetation.

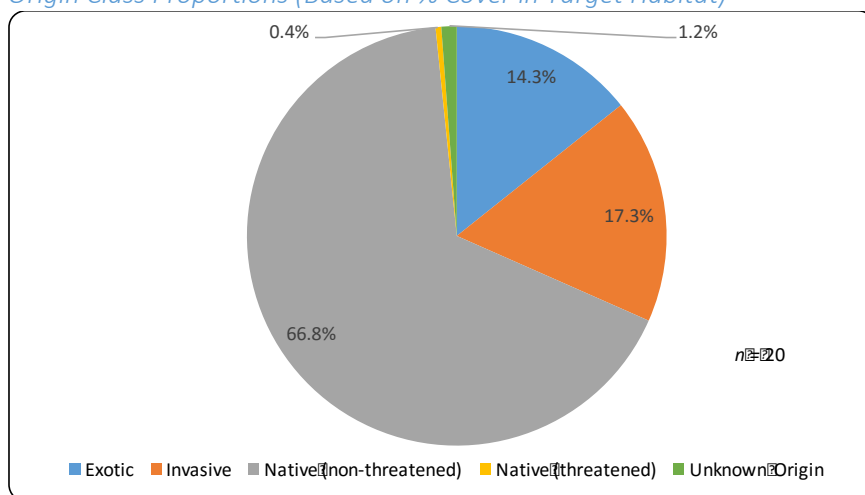
### Origin Class Proportions (Based on % Cover in Target Habitat)

Community	Common Name	Scientific Name	Origin (N/T/E/I)	Wetland Indicator Status	Mean Absolute % Cover	CI (95%)	n	Relative Dominance (%)
1	Lyngbye's sedge	<i>Carex lyngbyei</i>	N	1	51.4	16.0	20	69.0
1	colonial bentgrass	<i>Agrostis capillaris</i>	E	3	13.0	6.6	20	16.4

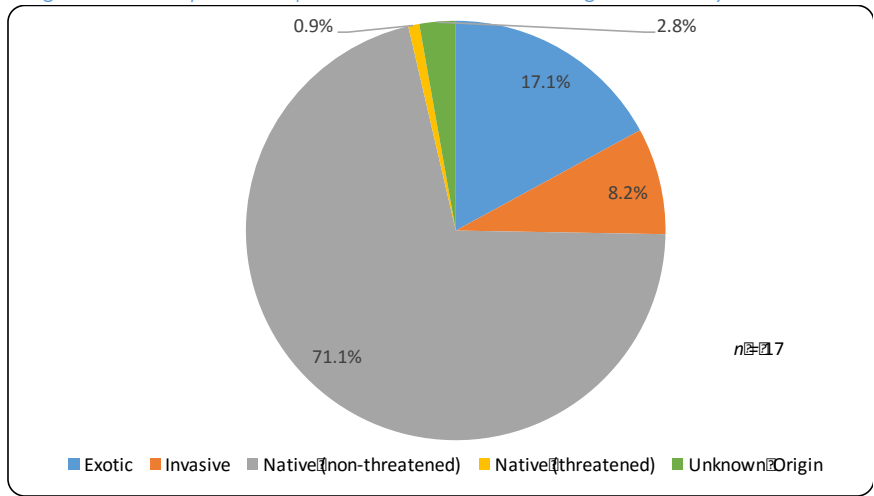
*Origin Class Proportions (Based on % Cover in Target Habitat)*

Community	Common Name	Scientific Name	Origin (N/T/E/I)	Wetland Indicator Status	Mean Absolute % Cover	CI (95%)	n	Relative Dominance (%)
1	Lyngbye's sedge	<i>Carex lyngbyei</i>	N	1	27.2	17.6	17	35.0
1	European forget-me-not	<i>Myosotis scorpioides</i>	E	2	7.4	5.3	17	12.4
1	colonial bentgrass	<i>Agrostis capillaris</i>	E	3	7.0	4.1	17	11.7
1	common spike-rush	<i>Eleocharis palustris</i>	N	1	9.9	7.3	17	11.5

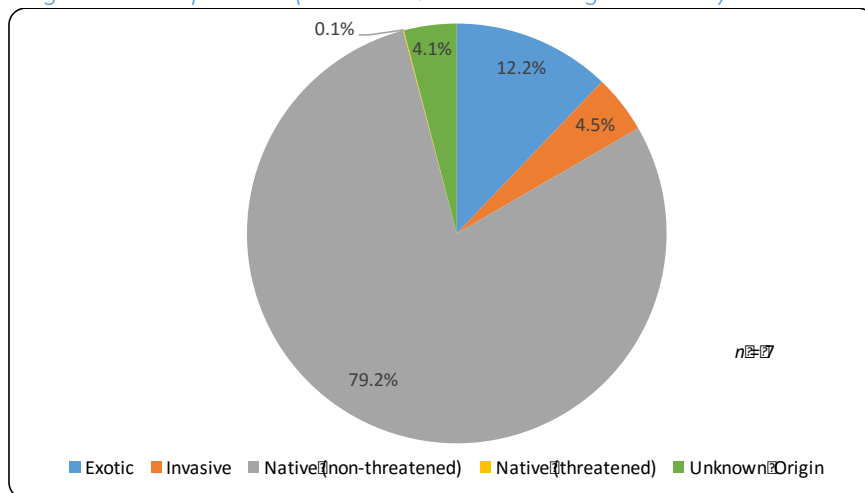
### Origin Class Proportions (Based on % Cover in Target Habitat)

Community	Common Name	Scientific Name	Origin (N/T/E/I)	Wetland Indicator Status	Mean Absolute % Status	CI (95%)	n	Relative Dominance (%)
1	jointed rush	<i>Juncus articulatus</i>	N	1	23.9	5.7	7	28.0
1	Baltic rush	<i>Juncus balticus</i>	N	2	20.7	11.6	7	20.3
1	Lyngbye's sedge	<i>Carex lyngbyei</i>	N	1	14.7	8.0	7	20.2
2	Lyngbye's sedge	<i>Carex lyngbyei</i>	N	1	3.7	4.0	3	81.5

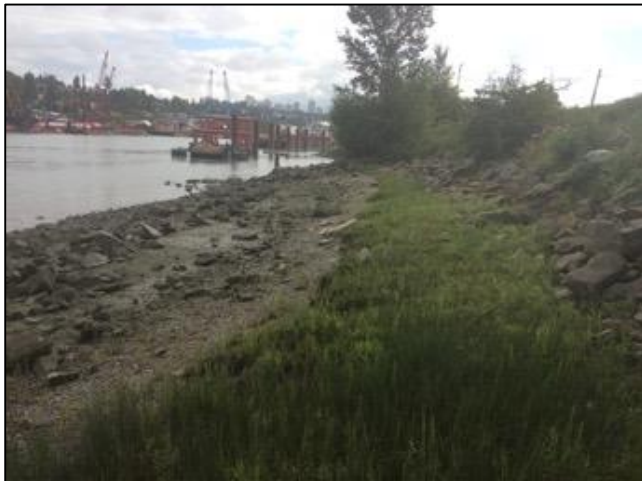
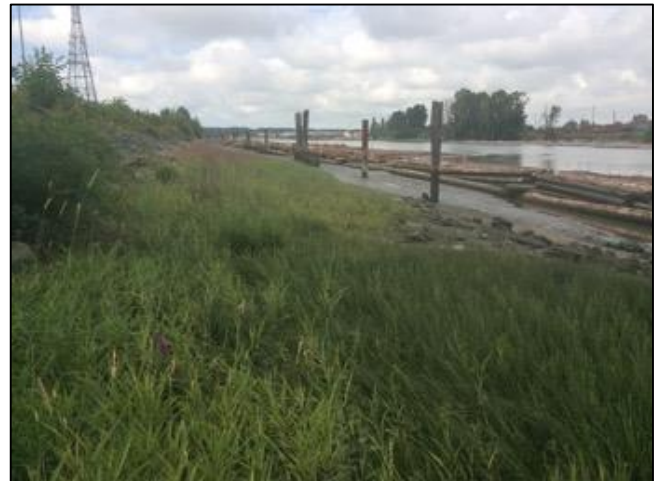
Mitigation			
Impact	Priority Rank (1 Low - 5 High)	Action Required	Comments
Erosion	3	Install erosion protection structures.	Nearby natural marsh is not as eroded, and protected by log boom structures (see bottom photo). High boat traffic was observed. Current appears to be strengthened and directed to foreshore by bridge piling.
Bare Ground	2	Plant unvegetated areas with appropriate native species.	Bare ground should not be addressed without first addressing erosion issues. Large areas of exposed substrate present, totaling a mean % cover of 24.0 +/- 11.7 in target habitat.
Invasive Species	1	Remove invasive species in and around compensation site.	Few invasives were observed on site, totaling a mean % cover of 4.4 +/- 2.7. Invasives should be removed while still unestablished. Nearby invasives in surrounding riparian and marsh habitat threaten to advance into the marsh, and may be treated as a proactive measure.

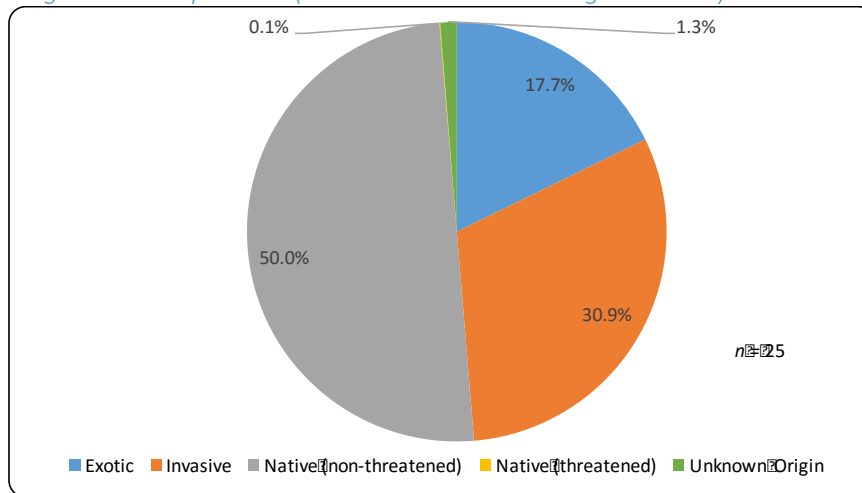
### Origin Class Proportions (Based on % Cover in Target Habitat)

Community	Common Name	Scientific Name	Origin (N/T/E/I)	Wetland Indicator Status	Mean Absolute % Cover	CI (95%)	n	Relative Dominance (%)
1	reed canarygrass	<i>Phalaris arundinacea</i>	I	2	23.4	11.9	25	39.7
1	Lyngbye's sedge	<i>Carex lyngbyei</i>	N	1	14.2	8.3	25	13.1

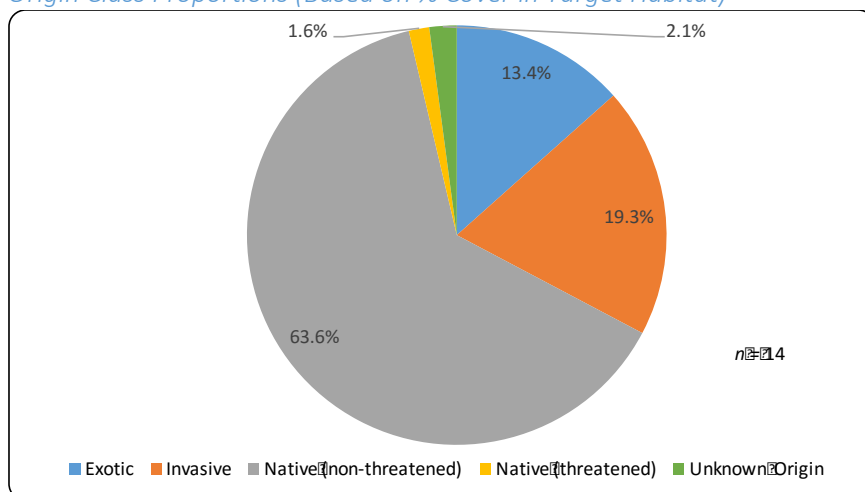
### Origin Class Proportions (Based on % Cover in Target Habitat)

Community	Common Name	Scientific Name	Origin (N/T/E/I)	Wetland Indicator Status	Mean Absolute % Cover	CI (95%)	n	Relative Dominance (%)
1	Lyngbye's sedge	<i>Carex lyngbyei</i>	N	1	30.3	13.8	14	29.3
1	reed canarygrass	<i>Phalaris arundinacea</i>	N	2	18.7	14.3	14	18.1

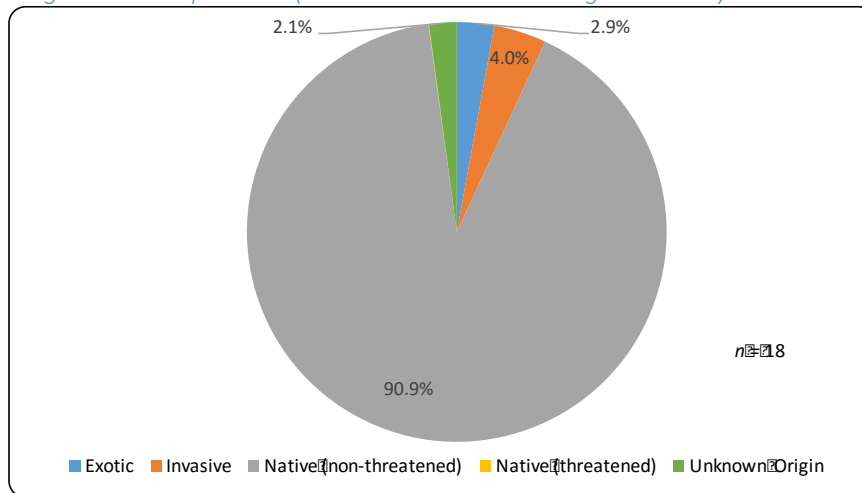
### Origin Class Proportions (Based on % Cover in Target Habitat)

Community	Common Name	Scientific Name	Origin (N/T/E/I)	Wetland Indicator Status	Mean Absolute % Cover	CI (95%)	n	Relative Dominance (%)
1	jointed rush	<i>Juncus articulatus</i>	N	1	26.8	14.6	18	59.2
1	common cattail	<i>Typha latifolia</i>	N	1	10.3	7.5	18	16.2
2	pond water-starwort	<i>Callitriche stagnalis</i>	E	1	26.5	23.3	6	58.9
2	jointed rush	<i>Juncus articulatus</i>	N	1	9.7	9.7	6	20.2
2	pigmyweed	<i>Crassula aquatica</i>	N	1	6.3	6.3	6	11.5

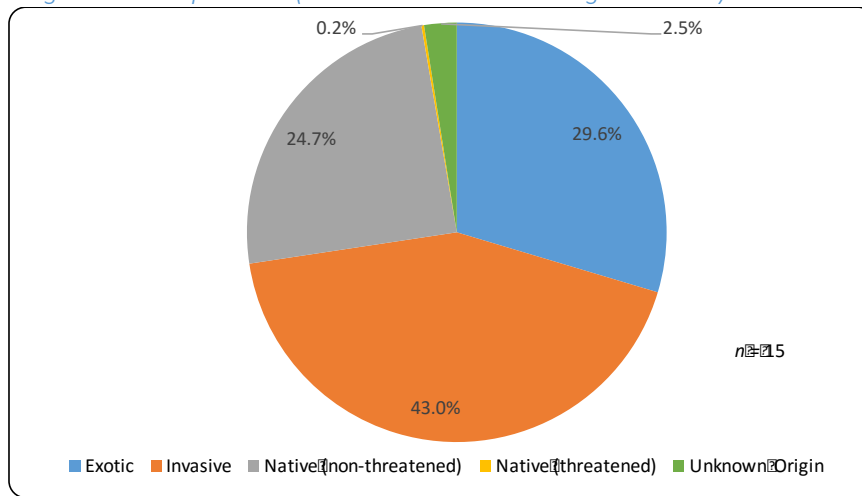
### Origin Class Proportions (Based on % Cover in Target Habitat)

Community	Common Name	Scientific Name	Origin (N/T/E/I)	Wetland Indicator Status	Mean Absolute % Cover	CI (95%)	n	Relative Dominance (%)
1	reed canarygrass	<i>Phalaris arundinacea</i>	I	2	34.0	17.8	15	47.1
1	European forget-me-not	<i>Myosotis scorpioides</i>	E	2	12.3	12.8	15	11.0

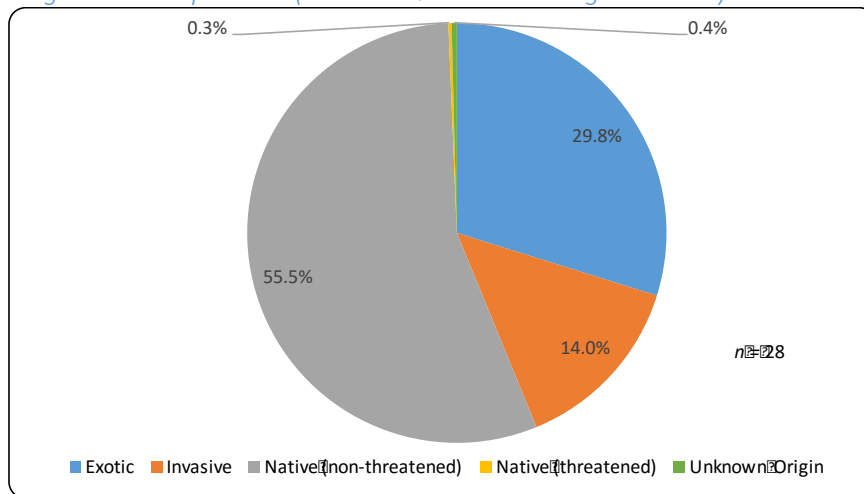
### Origin Class Proportions (Based on % Cover in Target Habitat)

Community	Common Name	Scientific Name	Origin (N/T/E/I)	Wetland Indicator Status	Mean Absolute % Cover	CI (95%)	n	Relative Dominance (%)
1	European forget-me-not	<i>Myosotis scorpioides</i>	E	2	18.7	6.2	28	33.5
1	Lyngbye's sedge	<i>Carex lyngbyei</i>	N	1	22.9	12.1	28	23.7
1	colonial bentgrass	<i>Agrostis capillaris</i>	E	3	10.9	7.0	28	11.3
2	pond water-starwort	<i>Callitriche stagnalis</i>	E	1	30.4	22.7	11	86.4

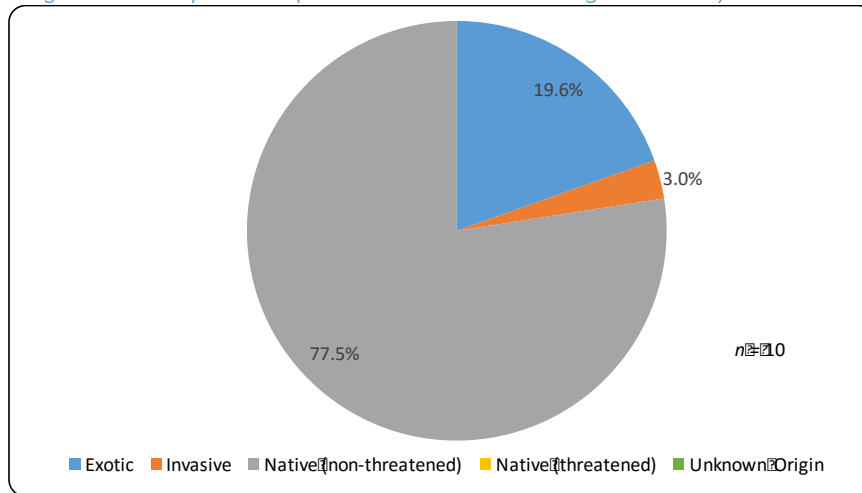
Origin Class Proportions (Based on % Cover in Target Habitat)

Community	Common Name	Scientific Name	Origin (N/T/E/I)	Wetland Indicator Status	Mean Absolute % Cover	CI (95%)	n	Relative Dominance (%)
1	Baltic rush	<i>Juncus balticus</i>	N	2	23.0	16.2	10	76.8
2	marshpepper smartweed	<i>Persicaria hydropiper</i>	E	1	12.0	14.4	7	41.4
2	pigmyweed	<i>Crassula aquatica</i>	N	1	4.4	3.7	7	18.3

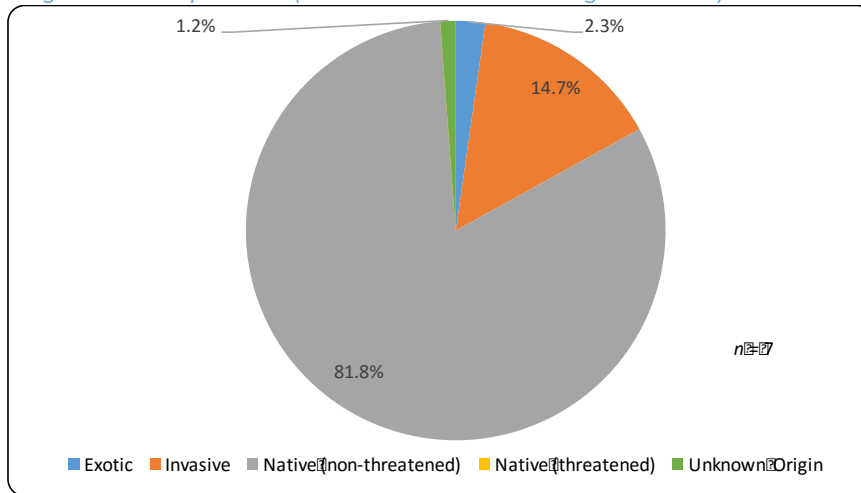
### Origin Class Proportions (Based on % Cover in Target Habitat)

Community	Common Name	Scientific Name	Origin (N/T/E/I)	Wetland Indicator Status	Mean Absolute % Cover	CI (95%)	n	Relative Dominance (%)
1	Baltic rush	<i>Juncus balticus</i>	N	2	48.6	28.6	7	44.1
1	Lyngbye's sedge	<i>Carex lyngbyei</i>	N	1	13.4	13.0	7	14.6
1	reed canarygrass	<i>Phalaris arundinacea</i>	I	2	11.0	6.2	7	12.0
