## Appendix V – Marsh Habitat Summary Data

## Appendix VII – Marsh Compensation Site Descriptions

Figure 1. Locations of FREMP compensation marshes surveyed July-October 2015. Large scale map features (e.g. precise locations, site boundaries, vegetation communities) can be viewed on the FREMP-BIEAP Atlas online, under the 2015 Field Data map layer: [http://www.cmNBC.ca/atlas\\_gallery/fremp-bieap-habitat-atlas](http://www.cmNBC.ca/atlas_gallery/fremp-bieap-habitat-atlas).

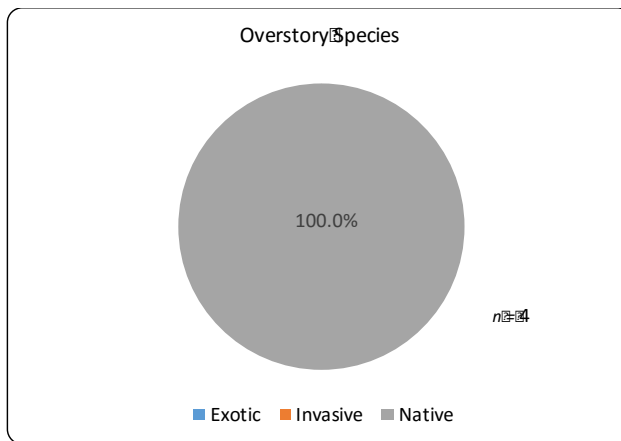
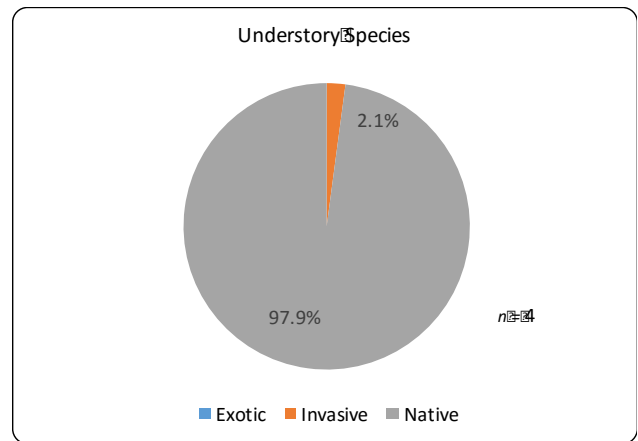
### Origin Class Proportions (Based on % Cover)

Community	Strata	Common Name	Scientific Name	Origin (N/T/E/I)	Stems/ha	Mean % Cover	CI (95%)	n
1	overstory	black cottonwood	<i>Populus balsamifera</i>	N	350.0	-	289.9	4
1	overstory	red alder	<i>Alnus rubra</i>	N	300.0	-	294.0	4
1	understory	Sitka willow	<i>Salix sitchensis</i>	N	-	19.8	5.4	4
1	understory	shining willow	<i>Salix lucida</i>	N	-	18.5	21.6	4

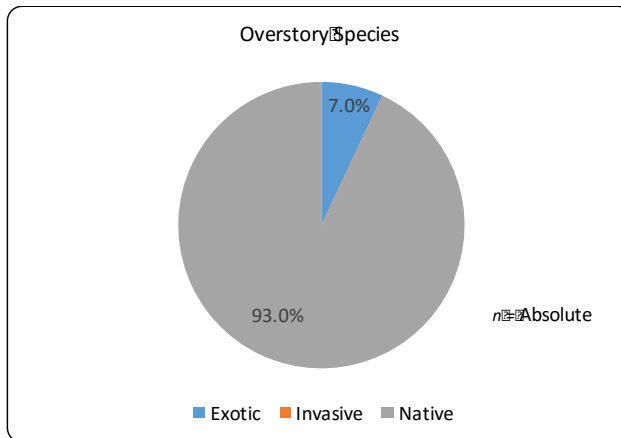
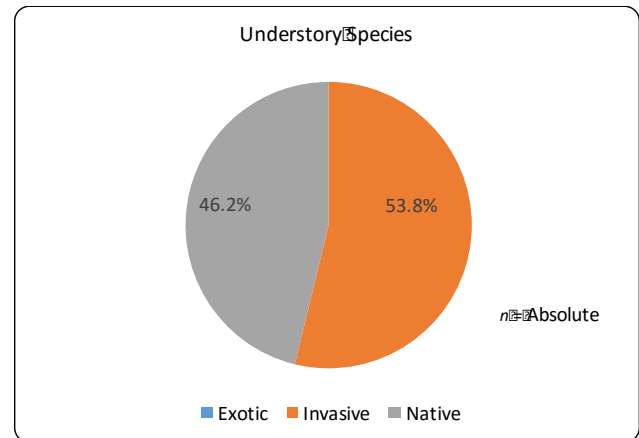
### Origin Class Proportions (Based on % Cover)

Community	Strata	Common Name	Scientific Name	Origin (N/T/E/I)	Stems/ha	Estimated Absolute % Cover	CI (95%)	n
1	overstory	black cottonwood	<i>Populus balsamifera</i>	N	2474.5	-	-	Absolute
1	overstory	red alder	<i>Alnus rubra</i>	N	353.5	-	-	Absolute
1	overstory	Scot's pine	<i>Pinus sylvestris</i>	E	212.1	-	-	Absolute
1	overstory	paper birch	<i>Betula papyrifera</i>	N	141.4	-	-	Absolute

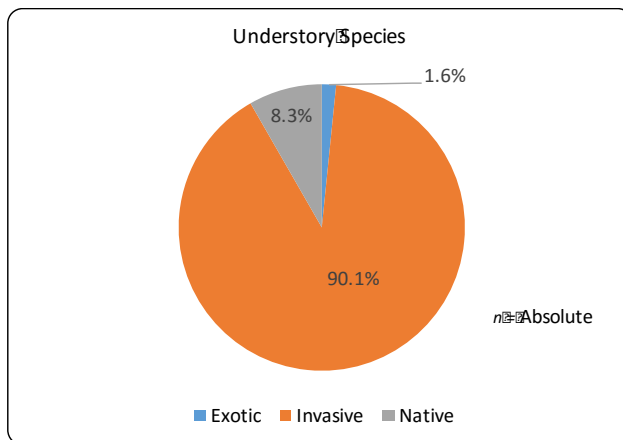
### Origin Class Proportions (Based on % Cover)

Community	Strata	Common Name	Scientific Name	Origin (N/T/E/I)	Stems/ha	Estimated Absolute % Cover	CI (95%)	n
1	understory	Himalayan blackberry	<i>Rubus armeniacus</i>	I	-	75.0	-	Absolute

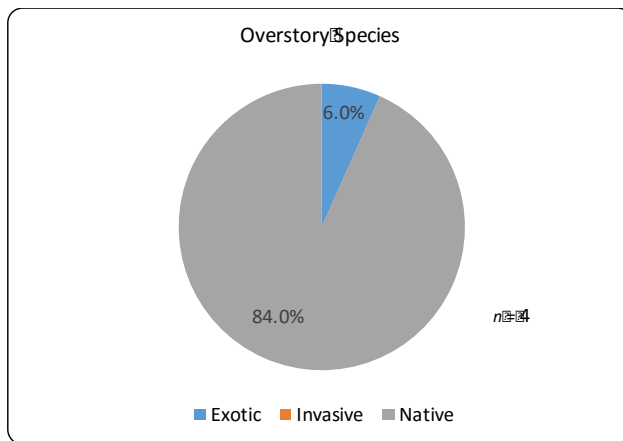
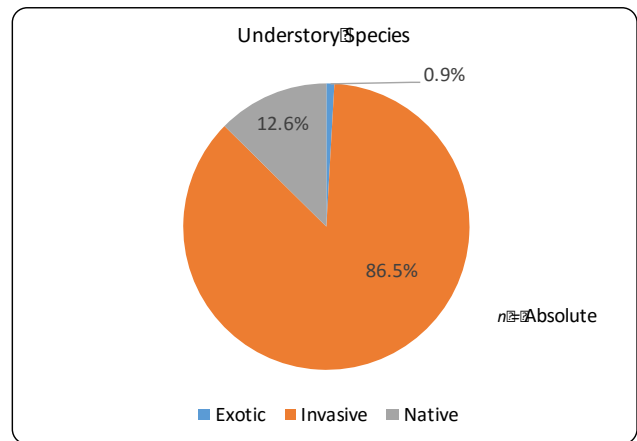
### Origin Class Proportions (Based on % Cover in Community 1)

Community	Strata	Common Name	Scientific Name	Origin (N/T/E/I)	Stems/ha	Mean/Absolute % Cover	CI (95%)	n
1	overstory	black cottonwood	<i>Populus balsamifera</i>	N	260.0	-	155.2	10
1	overstory	red alder	<i>Alnus rubra</i>	N	340.0	-	175.8	10
2	overstory	tulip tree	<i>Liriodendron tulipifera</i>	E	100.0	-	-	Absolute
1	understory	Himalayan blackberry	<i>Rubus armeniacus</i>	I	-	83.0	12.2	10

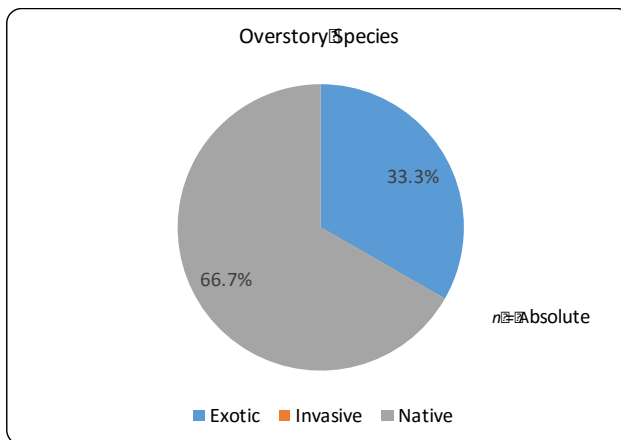
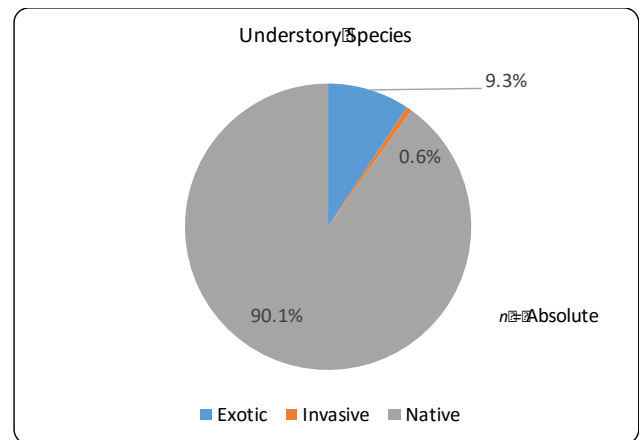
### Origin Class Proportions (Based on % Cover)

Community	Strata	Common Name	Scientific Name	Origin (N/T/E/I)	Stems/ha	Estimated Absolute % Cover	CI (95%)	n
1	overstory	purple leaf plum	<i>Prunus cerasifera</i>	E	255.2	-	-	Absolute
1	overstory	western hemlock	<i>Tsuga heterophylla</i>	N	199.8	-	-	Absolute
1	overstory	paper birch	<i>Betula papyrifera</i>	N	199.8	-	-	Absolute
1	understory	Nootka rose	<i>Rosa nutkana</i>	N	-	23.6	-	Absolute
1	understory	black twinberry	<i>Lonicera involucrata</i>	N	-	13.9	-	Absolute
1	understory	red-osier dogwood	<i>Cornus stolonifera</i>	N	-	12.4	-	Absolute

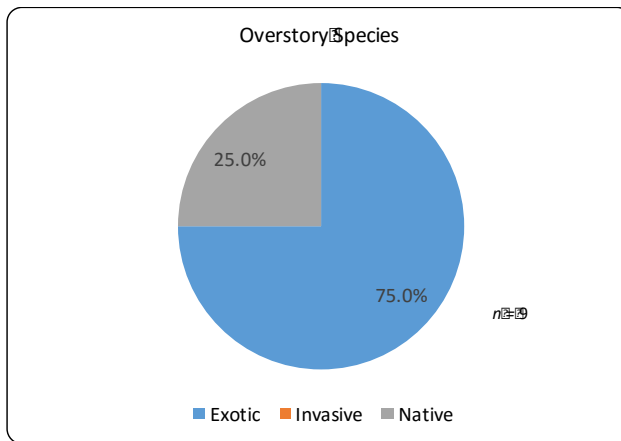
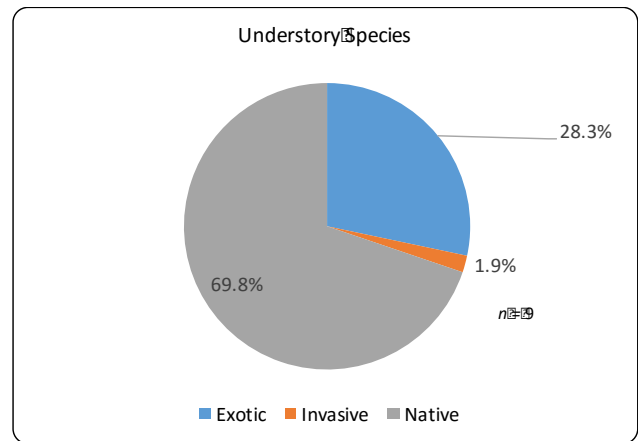
### Origin Class Proportions (Based on % Cover)

Community	Strata	Common Name	Scientific Name	Origin (N/T/E/I)	Stems/ha	Mean % Cover	CI (95%)	n
1	understory	snowberry	<i>Symphoricarpos albus</i>	N	-	20.7	19.5	9

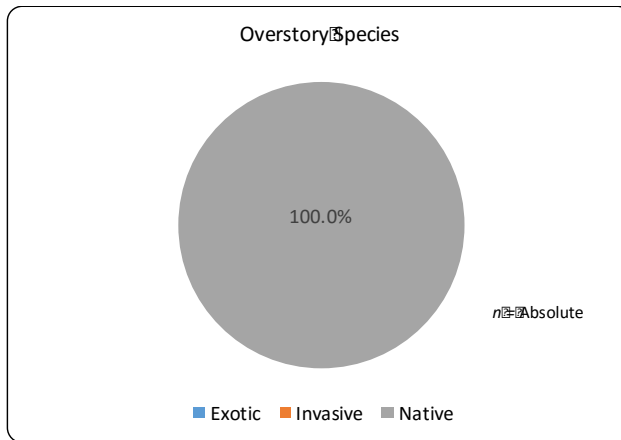
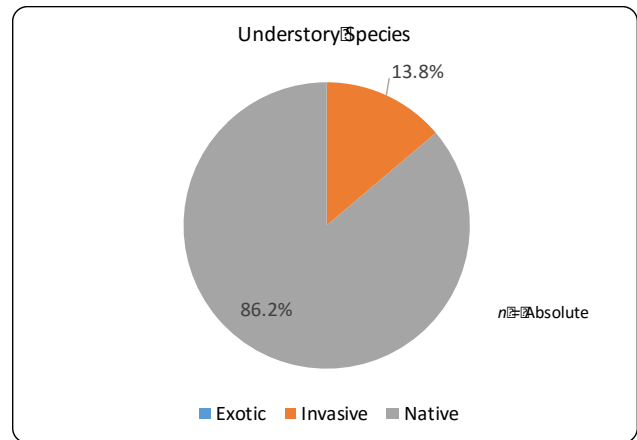
### Origin Class Proportions (Based on % Cover)

Community	Strata	Common Name	Scientific Name	Origin (N/T/E/I)	Stems/ha	Estimated Absolute % Cover	CI (95%)	n
1	understory	Pacific ninebark	<i>Physocarpus capitatus</i>	N	-	65.0	-	Absolute
1	understory	black twinberry	<i>Lonicera involucrata</i>	N	-	22.0	-	Absolute
1	understory	Himalayan blackberry	<i>Rubus armeniacus</i>	I	-	15.0	-	Absolute

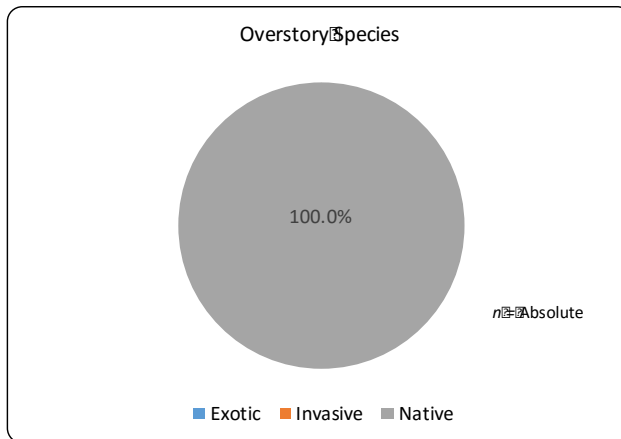
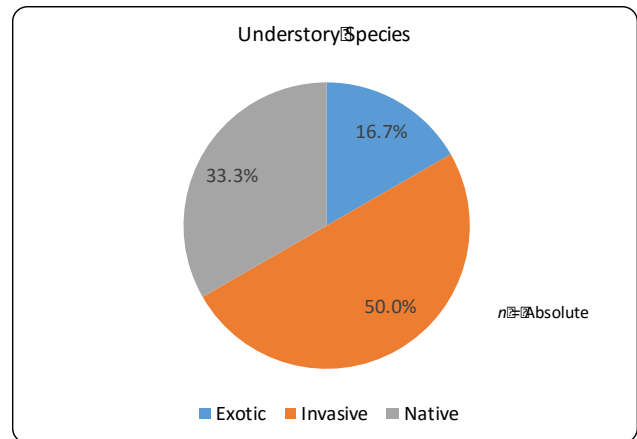
### Origin Class Proportions (Based on % Cover)

Community	Strata	Common Name	Scientific Name	Origin (N/T/E/I)	Stems/ha	Estimated Absolute % Cover	CI (95%)	n
1	overstory	red alder	<i>Alnus rubra</i>	N	168.8	-	-	Absolute
1	understory	Himalayan blackberry	<i>Rubus armeniacus</i>	I	-	60.0	-	Absolute
1	understory	black hawthorn	<i>Crataegus douglasii</i>	N	-	25.0	-	Absolute
1	understory	dog rose	<i>Rosa canina</i>	E	-	20.0	-	Absolute
1	understory	Pacific crab apple	<i>Malus fusca</i>	N	-	10.0	-	Absolute

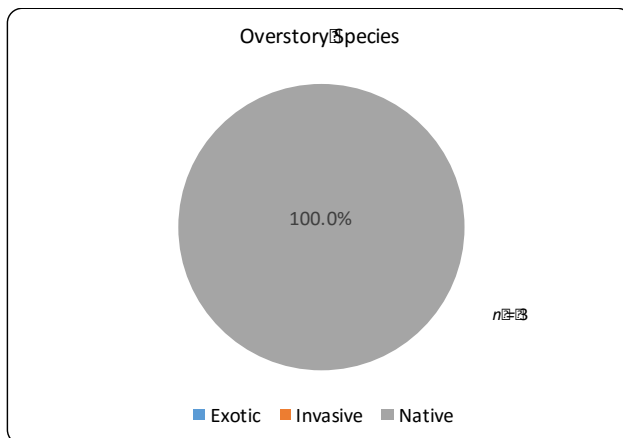
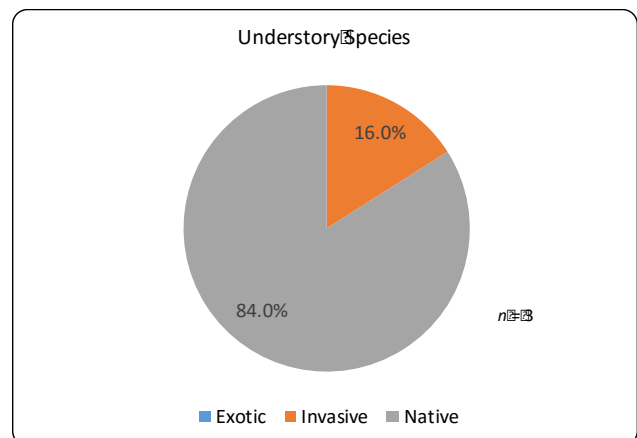
### Origin Class Proportions (Based on % Cover - Communities 1 & 2 Combined)

Community	Strata	Common Name	Scientific Name	Origin (N/T/E/I)	Stems/ha	Mean % Cover	CI (95%)	n
1	overstory	black cottonwood	<i>Populus balsamifera</i>	N	1533.3	-	1589.6	3
1	overstory	red alder	<i>Alnus rubra</i>	N	200.0	-	392.0	3
2	overstory	black cottonwood	<i>Populus balsamifera</i>	N	933.3	-	1829.3	3

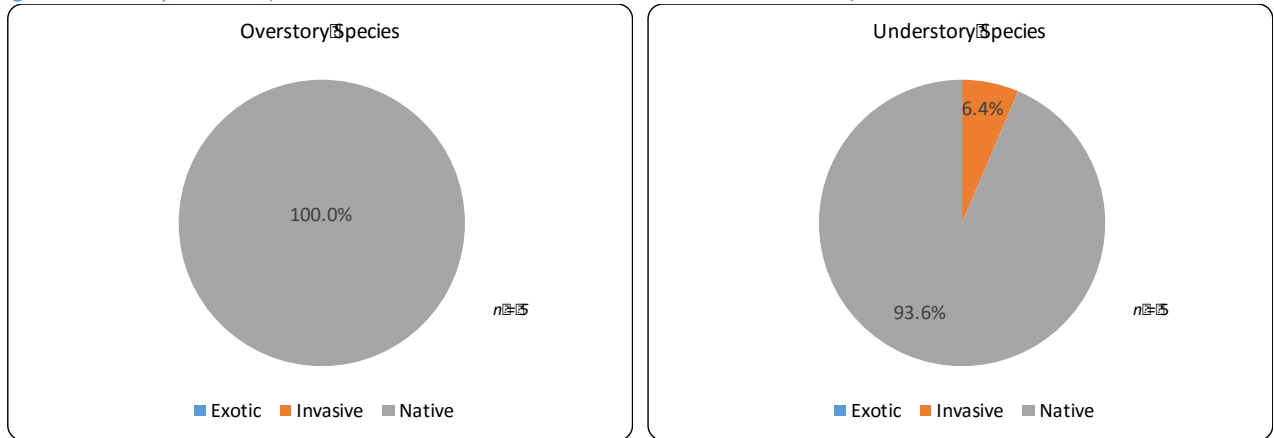
Origin Class Proportions (Based on % Cover - Communities 1 & 2 combined)

Community	Strata	Common Name	Scientific Name	Origin (N/T/E/I)	Stems/ha	Mean % Cover	CI (95%)	n
1	overstory	black cottonwood	<i>Populus balsamifera</i>	N	8420.0	-	3513.5	5
1	overstory	red alder	<i>Alnus rubra</i>	N	8420.0	-	7659.8	5
2	overstory	western redcedar	<i>Thuja plicata</i>	N	2120.0	-	3509.6	5
2	overstory	Douglas-fir	<i>Pseudotsuga menziesii</i>	N	1200.0	-	2352.0	5
2	understory	Sitka spruce	<i>Picea sitchensis</i>	N	-	15.6	18.1	5
